**Flood Control Project Maintenance  
Levee Inspections**

**Fall 2019 Levee Maintenance Deficiency Summary Report**

**San Joaquin River Basin**

## Reclamation District No. 2064 River Junction

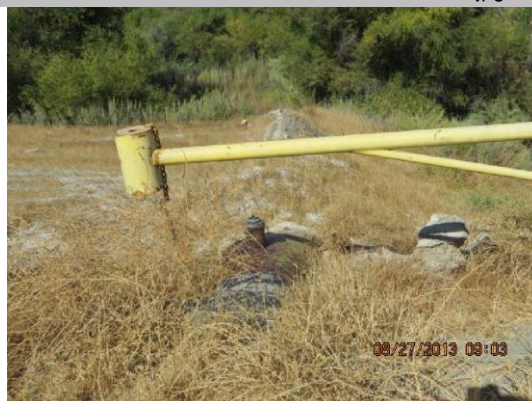
Photo 2 of 3 : UCIP\_FA\_2019\_18718\_31285.jpg

LM Start	0.06	Rating **	M	Issue No.	46 (cont)	
LM End	0.06	Issue Type +	En	Location *		
Category	Supplemental			GPS Latitude/Longitude		
				Start	End	
Item	DRAFT DWR UCIP Field Study			37.709725 °	37.709725 °	
				-121.267534 °	-121.267534 °	
DWR ID	20512					
Comment Code						
Inspector Comment						
DS_ID:20512 FS_ID:18718 EP_NO: 13907 Repair Type: Non-Urgent Crossing Status: Found UCIP Comments: This pipe has less than 1-foot of cover. FIELD_STRUCT_DESC: 1 of 3: 24-inch coated steel drainage discharge pipe through the levee, 2 feet below the crown. Two 100-horsepower and one 75-horsepower pumps on the landside (LS) toe. Siphon breaker on the waterside (WS) shoulder. (Permit No. 13907, 1985 - Reclamation District No. 2064). [Additional Reference(s): DWR Levee Log, 2005]. FS Date: 8/27/2013

Pipe and siphon breaker visible on WS shoulder.

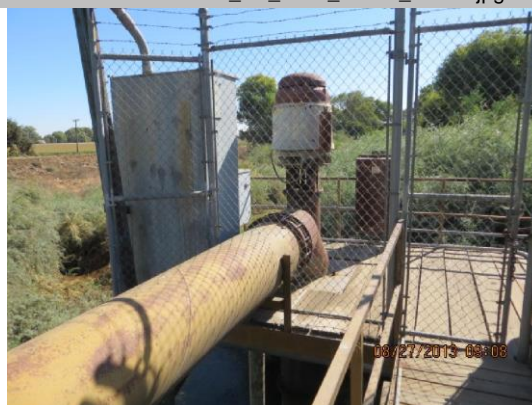
Photo 3 of 3 : UCIP\_FA\_2019\_18718\_31284.jpg

Pump on wooden pier on LS toe.

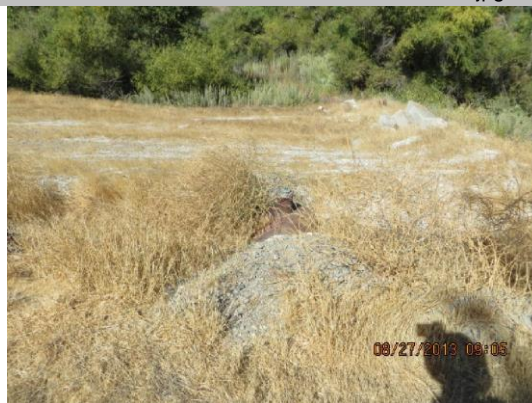
Photo 2 of 3 : UCIP\_FA\_2019\_22729\_38457.jpg

LM Start	0.06	Rating **	M	Issue No.	47
LM End	0.06	Issue Type +	En	Location *	
Category	Supplemental			GPS Latitude/Longitude	
				Start	End
Item	DRAFT DWR UCIP Field Study			37.709698 °	37.709698 °
				-121.267536 °	-121.267536 °
DWR ID	20527				
Comment Code					
Inspector Comment					
DS_ID:20527 FS_ID:22729 EP_NO: 13907 Repair Type: Non-Urgent Crossing Status: Found UCIP Comments: This pipe has less than 1-foot of cover. FIELD_STRUCT_DESC: 2 of 3: 24-inch coated steel drainage discharge pipe through the levee, 2 feet below the crown. Two 100-horsepower and one 75-horsepower pumps on pier at the landside (LS) toe. Siphon breaker on the waterside (WS) shoulder. (Permit No. 13907, 1985 - Reclamation District No. 2064). [Additional Reference(s): DWR Levee Log, 2005]. FS Date: 8/27/2013

Pipe and siphon breaker on WS shoulder.

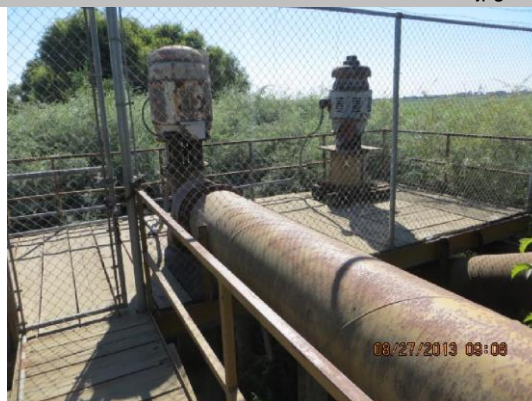
Photo 3 of 3 : UCIP\_FA\_2019\_22729\_38456.jpg

Pump on wooden pier at LS toe.

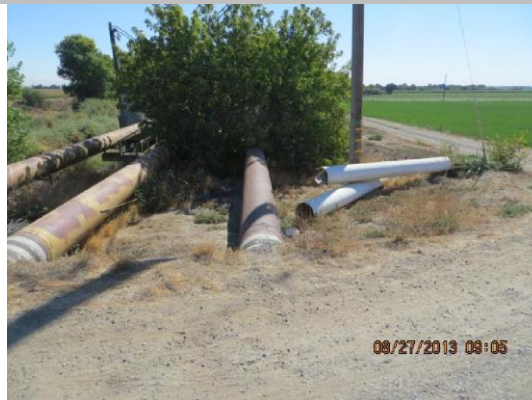
Photo 1 of 3 : UCIP\_FA\_2019\_18720\_31294.jpg

LM Start	0.06	Rating **	M	Issue No.	48
LM End	0.06	Issue Type +	En	Location *	
Category	Supplemental			GPS Latitude/Longitude	
				Start	End
Item	DRAFT DWR UCIP Field Study			37.709672 °	37.709672 °
				-121.267532 °	-121.267532 °
DWR ID	20528				
Comment Code					
Inspector Comment					
DS_ID:20528 FS_ID:18720 EP_NO: 13907 Repair Type: Non-Urgent Crossing Status: Found UCIP Comments: This pipe has less than 1-foot of cover. FIELD_STRUCT_DESC: 3 of 3: 24-inch coated steel drainage discharge pipe through the levee, 1 foot below the crown. Two 100-horsepower and one 75-horsepower pumps on the landside (LS) toe. Siphon breaker on the waterside (WS) shoulder. (Permit No. 13907, 1985 - Reclamation District No. 2064). [Additional Reference(s): DWR Levee Log, 2005]. FS Date: 8/27/2013

Steel pipe visible on LS.

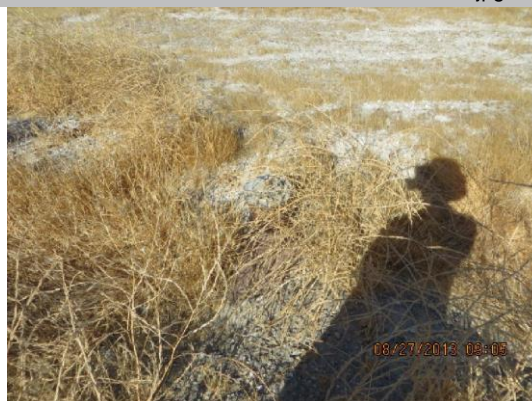
Photo 2 of 3 : UCIP\_FA\_2019\_18720\_31293.jpg

Siphon breaker visible on WS shoulder.

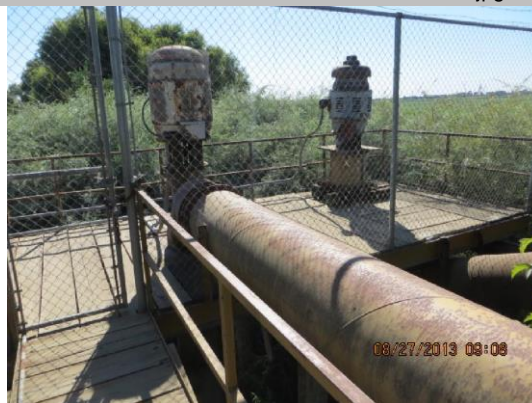
Photo 3 of 3 : UCIP\_FA\_2019\_18720\_31292.jpg

Pump on pier on LS.

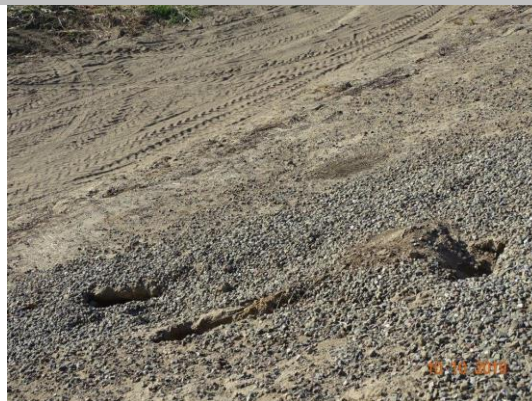
Photo 1 of 1 : FA\_2019\_RD2064\_313\_27\_20191111\_00054.jpg

View of large rodent burrows on landside slope. Fall 2019

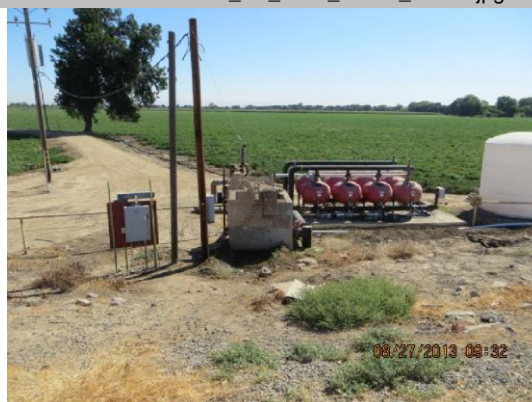
Photo 2 of 3 : UCIP\_FA\_2019\_40792\_31376.jpg

Comment Code						
Inspector Comment						
DS_ID:20533						
FS_ID:40792						
EP_NO: N/A						
Repair Type: Non-Urgent						
Crossing Status: Found						
UCIP Comments: Pump and slant pipe missing from structure on WS slope.						
FIELD_STRUCT_DESC: 12-inch concrete encased steel irrigation pipe through the levee, 13 feet below the crown. Slant pump on the waterside (WS) toe. Slide gate in a 36-inch corrugated metal pipe (CMP) riser on the WS shoulder. 6-foot by 6-foot concrete distribution box and filter plant on the landside (LS) toe. 2-inch galvanized iron electrical conduit at the same location. [Additional Reference(s): DWR Levee Log, 2005. USACE San Joaquin O&M Manual 3, December 1968, (HLM 1.24)].						
FS Date: 8/27/2013

Concrete distribution box and filter plant on LS toe.

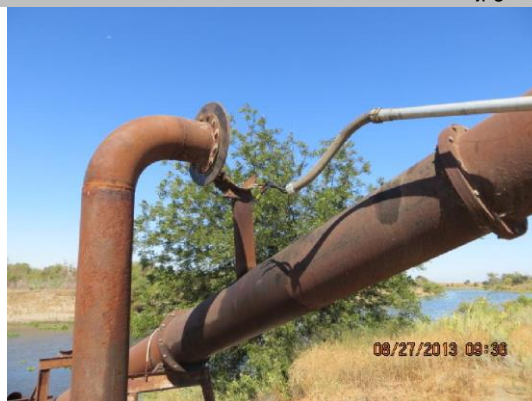
Photo 3 of 3 : UCIP\_FA\_2019\_40792\_31375.jpg

Pump and slant pipe missing from structure on WS slope.

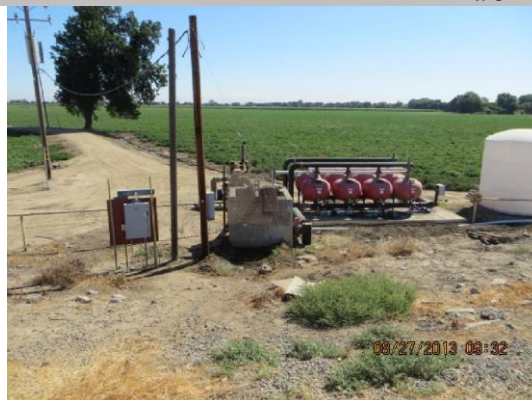
Photo 2 of 3 : UCIP\_FA\_2019\_53378\_38461.jpg

Comment Code						
Inspector Comment						
DS_ID:20524 FS_ID:53378 EP_NO: 3739 Repair Type: Urgent Crossing Status: Found UCIP Comments: 10/10/2018 There is a lot going on at this location; levee erosion and the same sink hole and pipe integrity issue on LS that looks like it has only gotten worse, installation of new steel pipe on WS, and the WS slope looks to have eroded some since the last inspection. Keeping as Urgent, and highly recommend full audit of this crossing, including permitted work and internal pipe inspection (D. Sanoski - DWR UCIP).11/16/2016 same as last inspection leak has created sink hole near concrete distribution box located on the LS. Hole in pipe is visible at sink hole. Need to contact owner to address leak on LS. Recommend an internal inspection be completed for the pipe through the levee to determine pipe integrity. (O. Magana - DWR UCIP)08/27/2013 Some leakage at connection between pipe and distro box on LS toe. This may indicate internal failure of pipe. (W. Wylie - DWR UCIP) FIELD_STRUCT_DESC: 16-inch coated steel irrigation pipe through the levee, 10.75 feet below the crown. 2-inch galvanized iron electrical conduit at the same location. Slant pump on the waterside (WS) toe. Slide gate in a 36-inch corrugated metal pipe (CMP) riser on the WS shoulder. 6-foot by 6-foot concrete distribution box and filter plant on the landside (LS) toe. (16-inch pipe authorized under Permit No. 3739, 1961 - Mortensen and Barker). FS Date: 10/10/2018 1:10:00 PM

Concrete distribution box on LS toe with filter plant.

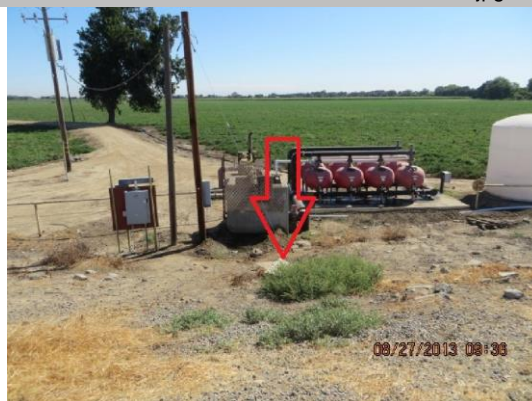
Photo 3 of 3 : UCIP\_FA\_2019\_53378\_38460.jpg

Leakage along pipe alignment on LS toe.

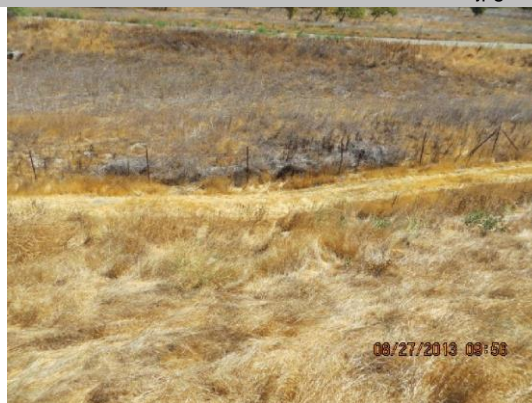
Photo 1 of 3 : UCIP\_FA\_2019\_18748\_31380.jpg

LM Start	<b>1.65</b>	Rating **	A/W	Issue No.	<b>51</b>
LM End	<b>1.65</b>	Issue Type +	Ma	Location *	
Category	Supplemental		GPS Latitude/Longitude		
			Start	End	
Item	DRAFT DWR UCIP LMA Responsibility		37.690072°	37.690072°	
			-121.269823°	-121.269823°	
DWR ID	20514				
Comment Code					
Inspector Comment					
DS_ID:20514 FS_ID:18748 EP_NO: N/A Repair Type: No Action Needed Crossing Status: Found UCIP Comments: FIELD_STRUCT_DESC: 30-inch by 30-inch reinforced concrete box drainage culvert through the levee, 15 feet below the crown. Slide gate in a concrete riser on the waterside (WS) shoulder. Concrete U-shaped headwalls on both ends. Flap gate on the WS end. [Additional Reference(s): DWR Levee Log, 2005. USACE San Joaquin O&M Manual 3, December 1968, (HLM 1.65)]. FS Date: 8/27/2013

Concrete headwall on LS toe.

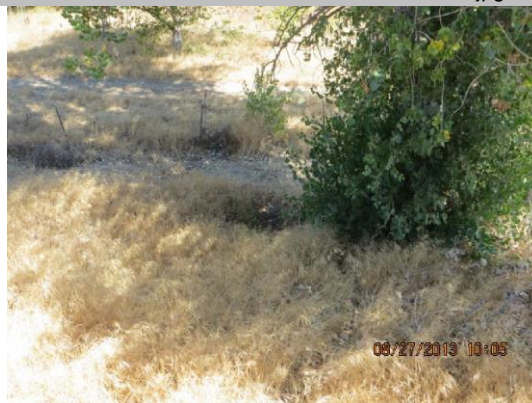
Photo 2 of 3 : UCIP\_FA\_2019\_18763\_31401.jpg

LM Start	1.94	Rating **	M	Issue No.	52
LM End	1.94	Issue Type +	Ma	Location *	
Category	Supplemental			GPS Latitude/Longitude	
				Start	End
Item	DRAFT DWR UCIP LMA Responsibility			37.689900 °	37.689900 °
				-121.264802 °	-121.264802 °
DWR ID	20515				
Comment Code					
Inspector Comment					
DS_ID:20515 FS_ID:18763 EP_NO: N/A Repair Type: Non-Urgent Crossing Status: Found UCIP Comments: Culvert filled nearly to the top with soil. FIELD_STRUCT_DESC: 30-inch by 30-inch reinforced concrete box drainage culvert through the levee, 14.7 feet below the crown. Slide gate in a concrete riser on the waterside (WS) slope. Concrete U-shaped headwalls on both ends. Flap gate on the WS end. [Additional Reference(s): DWR Levee Log, 2005. USACE San Joaquin O&M Manual 3, December 1968, (HLM 1.93)]. FS Date: 8/27/2013

Concrete U-shaped headwall on LS toe.

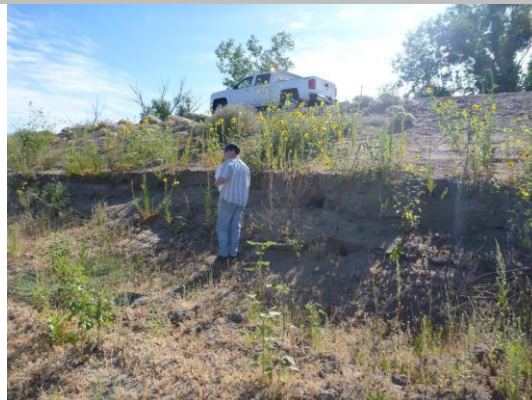
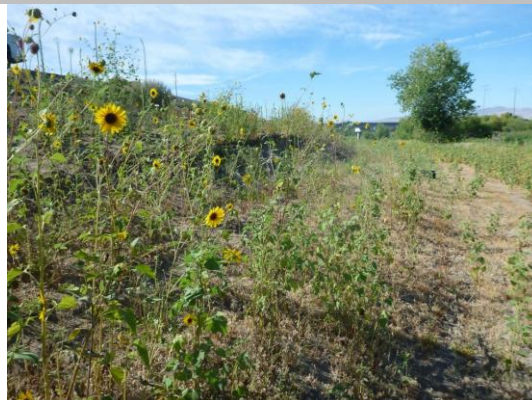
LM Start	3.26	Rating **	A/W	Issue No.	44
LM End	3.39	Issue Type +	Ma	Location *	
Category	Supplemental			GPS Latitude/Longitude	
				Start	End
Item	2017 Storm Damage			37.679100°	37.677800°
				-121.262600°	-121.264400°
DWR ID	LMA-488				
Comment Code					
Inspector Comment					
Levee Evaluation Comments					
Description:Erosion from high water flows caused erosion scarps from 12" to 30" in height. The area of damage is approximately 400 feet in length.					
Site ID No:582					
Site Designation:LMA-488					
Repair Type: Erosion					
Rating:Serious					
Field Date:8/14/2017					
Notes:

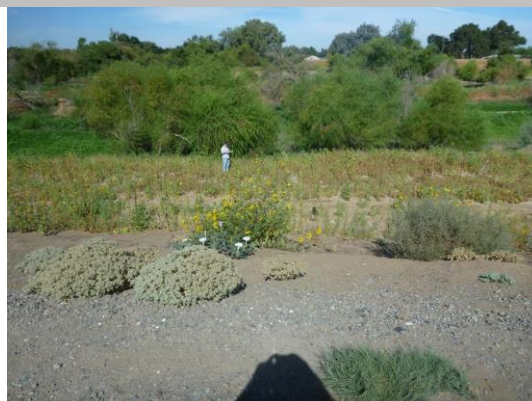
Photo 3 of 3 : FA\_2019\_RD2064\_313\_44\_20191210\_00059.jpg

LM Start	3.26	Rating **	A/W	Issue No.	44 (cont)
LM End	3.39	Issue Type +	Ma	Location *	
Category	Supplemental			GPS Latitude/Longitude	
				Start	End
Item	2017 Storm Damage			37.679100°	37.677800°
				-121.262600°	-121.264400°
DWR ID	LMA-488				
Comment Code					
Inspector Comment					
Levee Evaluation Comments					
Description:Erosion from high water flows caused erosion scarps from 12" to 30" in height. The area of damage is approximately 400 feet in length.					
Site ID No:582					
Site Designation:LMA-488					
Repair Type: Erosion					
Rating:Serious					
Field Date:8/14/2017					
Notes:

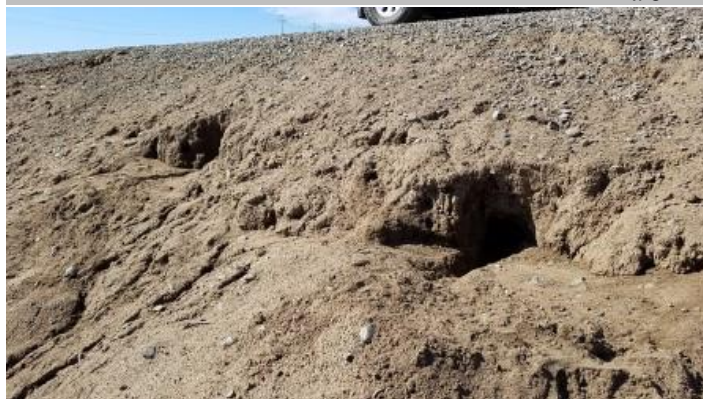
Photo 1 of 1 : FA\_2019\_RD2064\_313\_10\_20190830\_00001.jpg

LM Start	3.31	Rating **	M	Issue No.	10
LM End	3.45	Issue Type +	Ma	Location *	LS
Category	Earthen Levee			GPS Latitude/Longitude	
				Start	End
Item	Animal Control			37.678708 °	37.676786 °
				-121.263415 °	-121.264207 °
DWR ID	DWR_RD2064_01_f_2017_10				
Comment Code					
A3 : No rodents visible, but rodent burrows visible; need to backfill and compact or grout burrows.					
Inspector Comment

View of animal holes on levee slope. Fall 2018

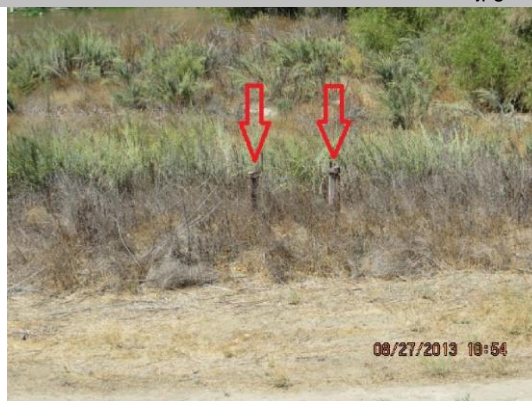
Photo 1 of 1 : UCIP\_FA\_2019\_22731\_38463.jpg

LM Start	3.46	Rating **	M	Issue No.	53	
LM End	3.46	Issue Type +	En	Location *		
Category	Supplemental			GPS Latitude/Longitude		
				Start		End
Item	DRAFT DWR UCIP Field Study			37.676751 °		37.676751 °
				-121.264193 °		-121.264193 °
DWR ID	20517					
Comment Code						
Inspector Comment						
DS_ID:20517						
FS_ID:22731						
EP_NO: N/A						
Repair Type: Non-Urgent						
Crossing Status: Indicator Found						
UCIP Comments: Neet to verify status of pipeline.						
FIELD_STRUCT_DESC: Underground gas line crossing; depth through the levee and size unknown. Found possible sign posts on WS toe.						
FS Date: 8/27/2013

Possible sign posts on WS toe.

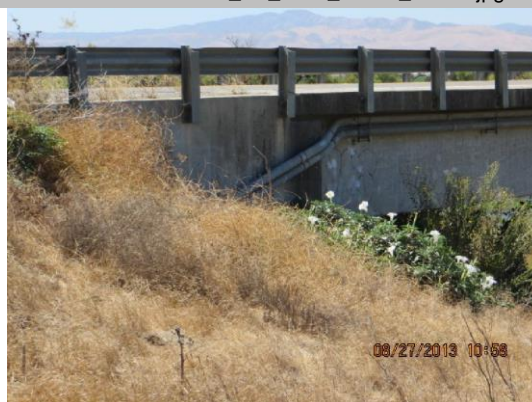
Photo 1 of 1 : UCIP\_FA\_2019\_22085\_37702.jpg

LM Start	3.49	Rating **	M	Issue No.	54
LM End	3.49	Issue Type +	En	Location *	
Category	Supplemental			GPS Latitude/Longitude	
				Start	End
Item	DRAFT DWR UCIP Field Study			37.676276 °	37.676276 °
				-121.264104 °	-121.264104 °
DWR ID	24059				
Comment Code					
Inspector Comment					
DS_ID:24059 FS_ID:22085 EP_NO: N/A Repair Type: Non-Urgent Crossing Status: Found UCIP Comments: Unable to identify purpose or permit for this crossing. FIELD_STRUCT_DESC: 1 of 2: 4-inch galvanized iron conduit of an unknown purpose through the levee, at an unknown depth. Visible on downstream side of the bridge. 3.5-foot by 6-foot steel vault on crown. FS Date: 8/27/2013

Upper conduit visible on DS side of bridge.

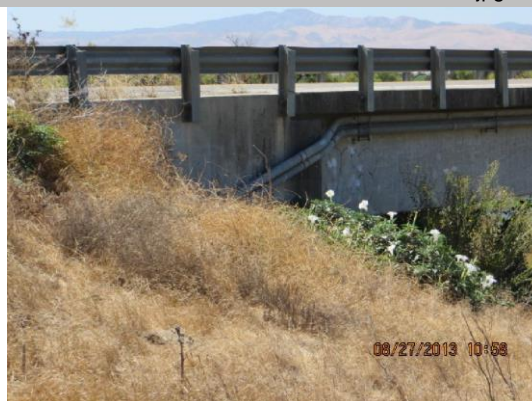
Photo 1 of 1 : UCIP\_FA\_2019\_22790\_38826.jpg

LM Start	3.49	Rating **	M	Issue No.	55
LM End	3.49	Issue Type +	En	Location *	
Category	Supplemental			GPS Latitude/Longitude	
				Start	End
Item	DRAFT DWR UCIP Field Study			37.676276 °	37.676276 °
				-121.264104 °	-121.264104 °
DWR ID	24060				
Comment Code					
Inspector Comment					
DS_ID:24060 FS_ID:22790 EP_NO: N/A Repair Type: Non-Urgent Crossing Status: Found UCIP Comments: Unable to identify purpose or permit for this crossing. FIELD_STRUCT_DESC: 2 of 2: 4-inch galvanized iron conduit through the levee at unknown depth below the crown. Visible on downstream side of the bridge. 3.5-foot by 6-foot steel vault on crown. FS Date: 8/27/2013

Lower conduit visible on DS side of bridge at WS slope.

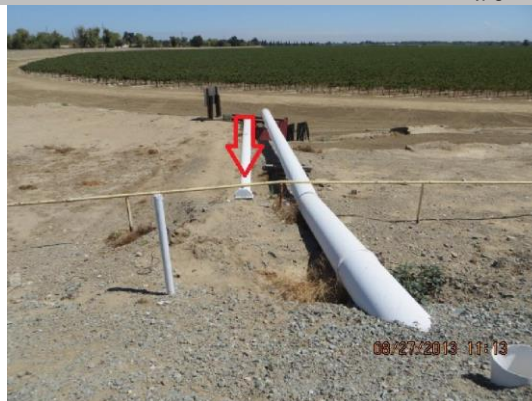
Photo 1 of 3 : UCIP\_FA\_2019\_19044\_31844.jpg

Pipe and gate valve on LS toe.

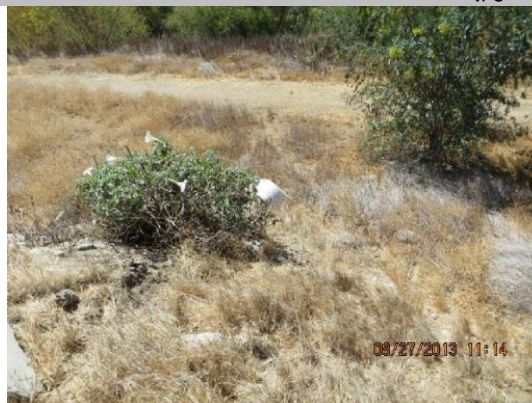
Photo 2 of 3 : UCIP\_FA\_2019\_22733\_38467.jpg

Pipe visible on WS slope.

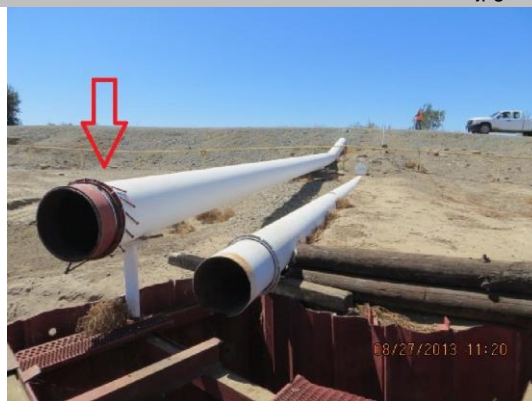
Photo 3 of 3 : UCIP\_FA\_2019\_22733\_38466.jpg

Pipe open at pump sump off LS toe.

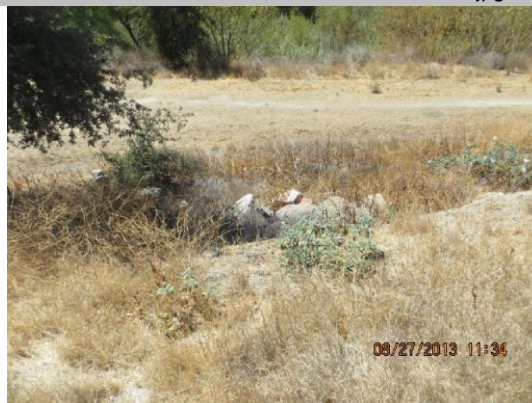
Photo 1 of 2 : UCIP\_FA\_2019\_19046\_31849.jpg

Concrete rubble on WS slope possible indicator of abandoned pipe location.

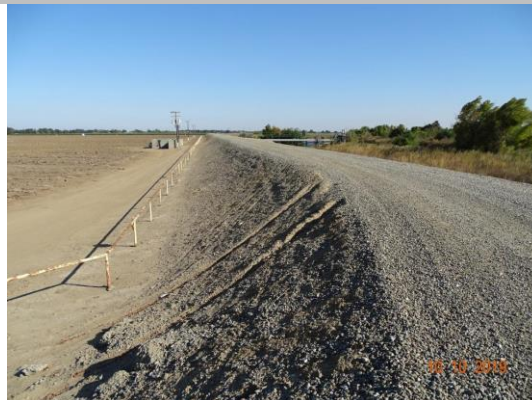
Photo 1 of 1 : FA\_2019\_RD2064\_313\_43\_20191111\_00056.jpg

View of tire ruts on landside slope caused by farm equipment accessing levee crown. Fall 2019

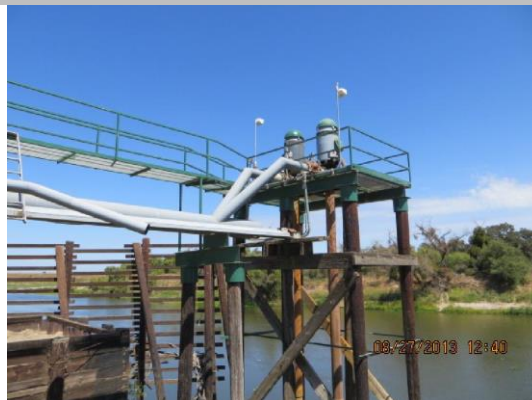
Photo 2 of 2 : UCIP\_FA\_2019\_19063\_31860.jpg

Pump platform, walkway, and fender remain in stream. No 24-1inch pipe found.

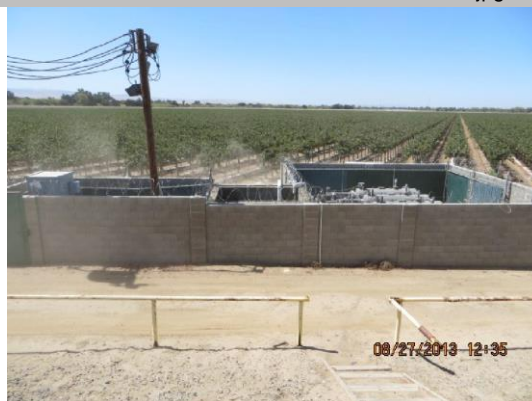
Photo 1 of 2 : UCIP\_FA\_2019\_19064\_31863.jpg

Concrete distribution box in center of structure on LS toe.

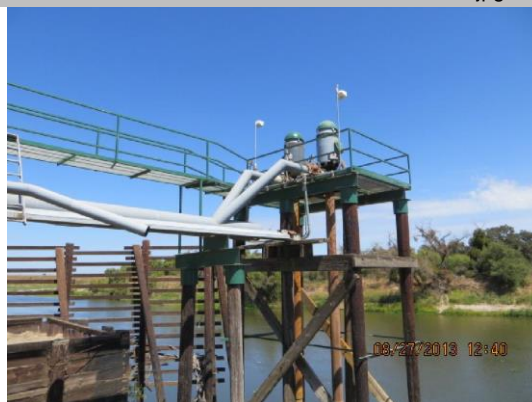
Photo 2 of 2 : UCIP\_FA\_2019\_19064\_31862.jpg

Pump platform and fender visible on WS toe.

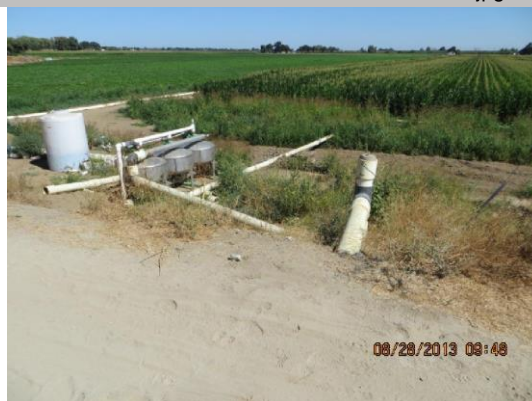
Photo 1 of 3 : UCIP\_FA\_2019\_44653\_37715.jpg

Pipe, vent, and filter plant on LS shoulder and LS toe.

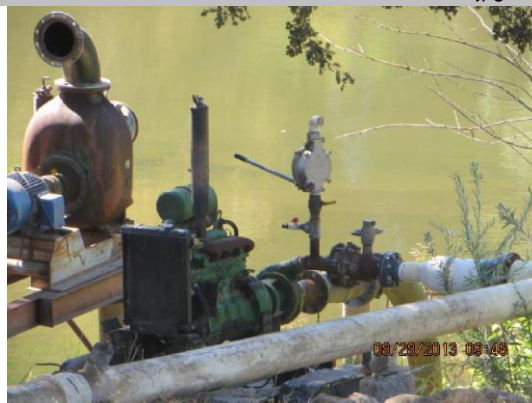
Photo 3 of 3 : UCIP\_FA\_2019\_44653\_37713.jpg

Portable pump on WS berm.

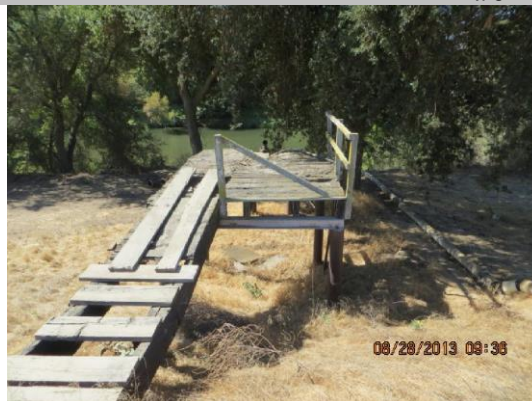
Photo 2 of 3 : UCIP\_FA\_2019\_51385\_31891.jpg

Deteriorated wooded pump platform on WS shoulder.

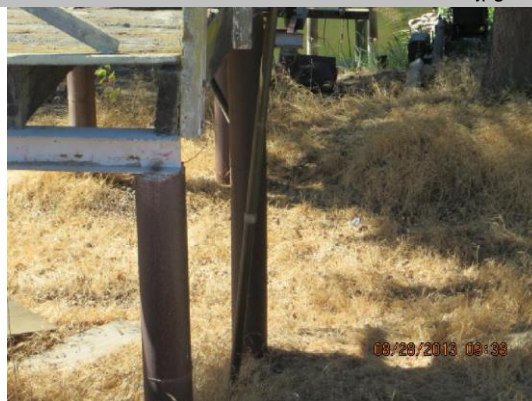
Photo 3 of 3 : UCIP\_FA\_2019\_51385\_31890.jpg

2-inch galvanized iron electrical conduit at same location.

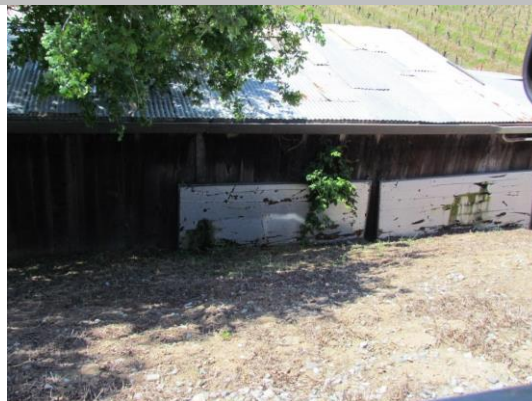
Photo 1 of 1 : FA\_2019\_RD2064\_314\_17\_20190830\_00001.jpg

RD 2064 looking upstream from levee mile 1.96 landside, building within the easement.

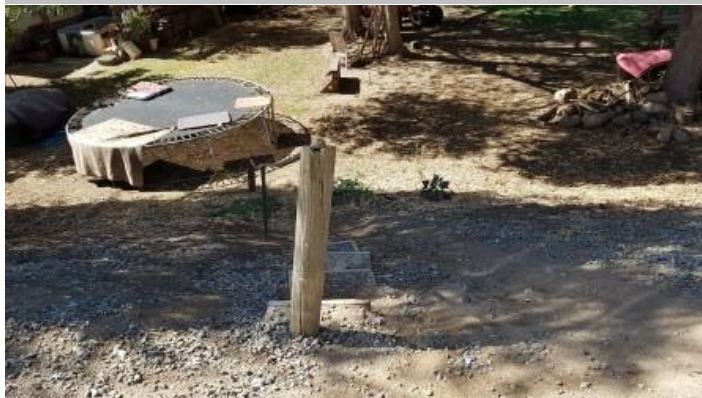
Photo 1 of 1 : FA\_2019\_RD2064\_314\_31\_20190830\_00006.jpg

View of stairway with railing that appears to be without a permit. Fall 2018

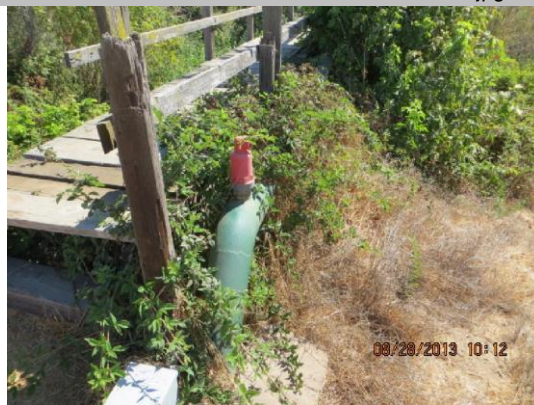
Photo 1 of 3 : UCIP\_FA\_2019\_22095\_37722.jpg

Pipe and vent visible on WS shoulder at wooden walkway.

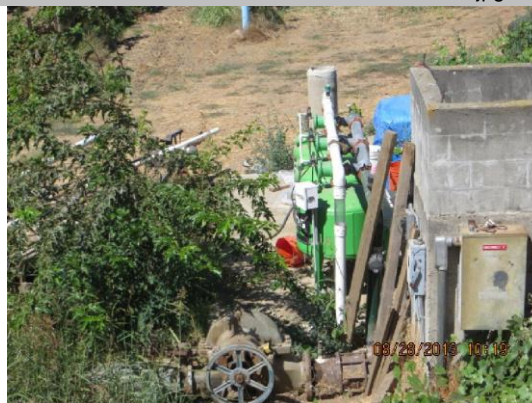
Photo 3 of 3 : UCIP\_FA\_2019\_22095\_37720.jpg

Filterplant visible on LS toe.

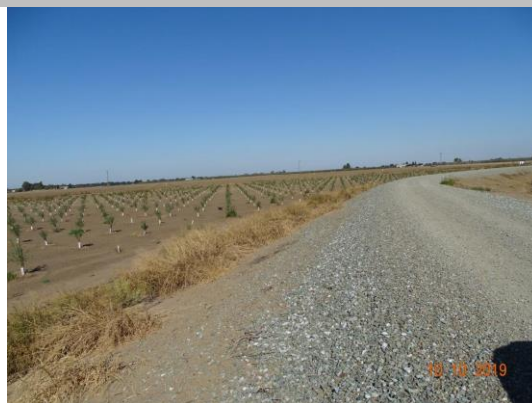
Photo 1 of 1 : FA\_2019\_RD2064\_314\_32\_20191111\_00055.jpg

View of vegetation on landside slope. Fall 2019

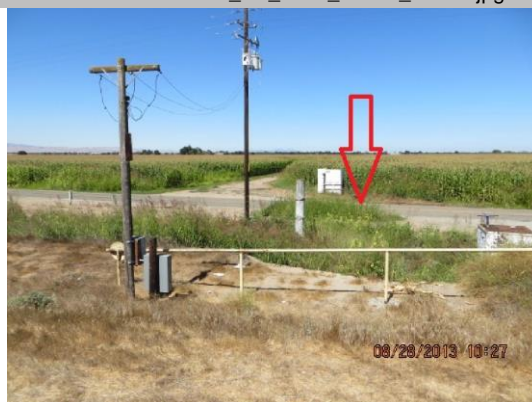
Photo 2 of 3 : UCIP\_FA\_2019\_19086\_31953.jpg

Wet area next to roadway off LS toe may indicate a leak. Power pole and meter on LS toe.

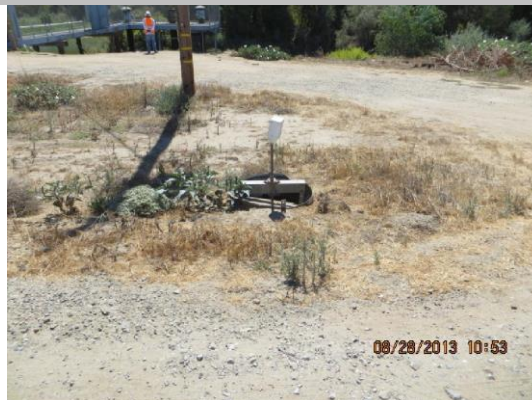
Photo 2 of 3 : UCIP\_FA\_2019\_41075\_31962.jpg

Slide gate in 36-inch CMP riser on WS slope.

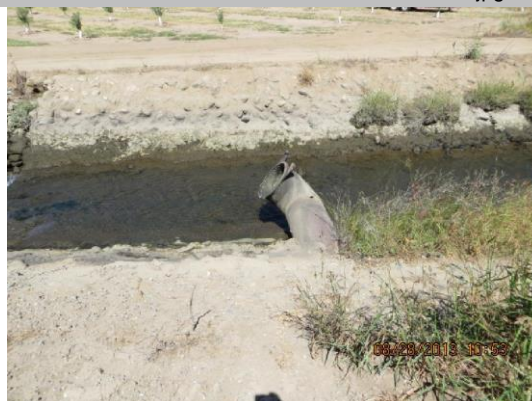
Photo 3 of 3 : UCIP\_FA\_2019\_41075\_31961.jpg

Pipe with missing flapgate on LS at concrete ditch.

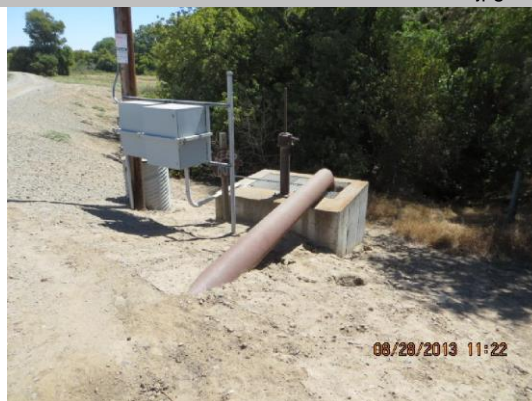
Photo 2 of 2 : UCIP\_FA\_2019\_22107\_37735.jpg

Pipe discharges into concrete riser on WS slope.

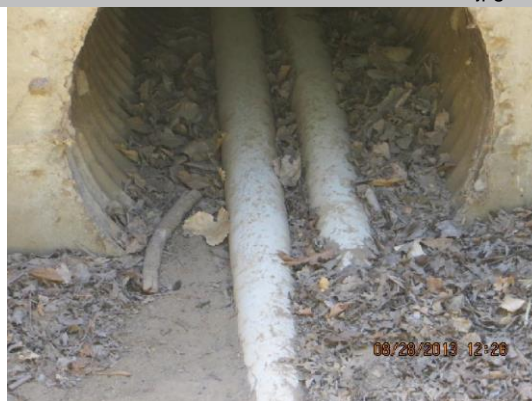
Photo 2 of 3 : UCIP\_FA\_2019\_22108\_37738.jpg

PVC pipe at right inside stormdrain on LS toe.

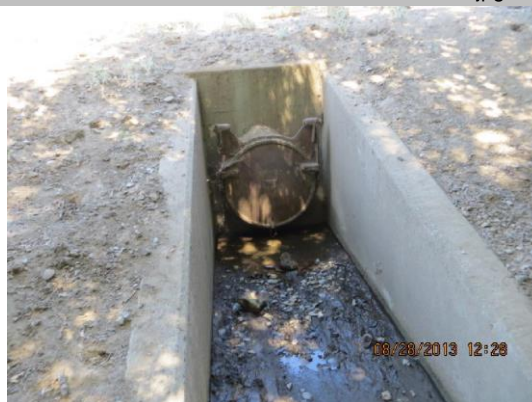
Photo 3 of 3 : UCIP\_FA\_2019\_22108\_37737.jpg

Evidence of discharge through PVC conduit on WS toe.

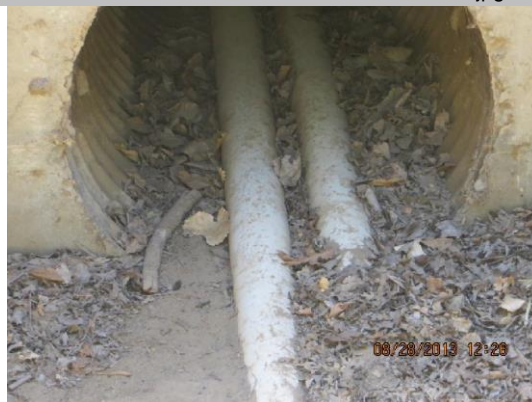
Photo 2 of 3 : UCIP\_FA\_2019\_22109\_37741.jpg

PVC conduit at left on LS toe.

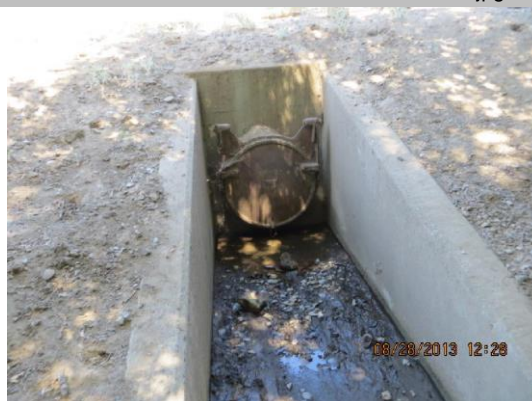
Photo 3 of 3 : UCIP\_FA\_2019\_22109\_37740.jpg

Evidence of discharge from PVC on WS toe.

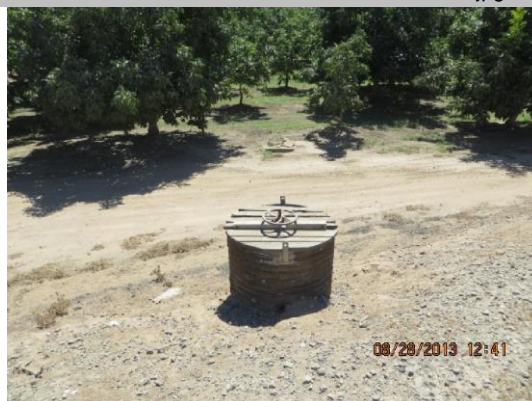
Photo 1 of 2 : UCIP\_FA\_2019\_19145\_32126.jpg

Slide gate in CMP riser on WS slope
